NATIONAL REGISTER OF HISTORIC PLACES  
INVENTORY -- NOMINATION FORM

William Hilleary House

Magruder House or Old Stone House

4703 Annapolis Road

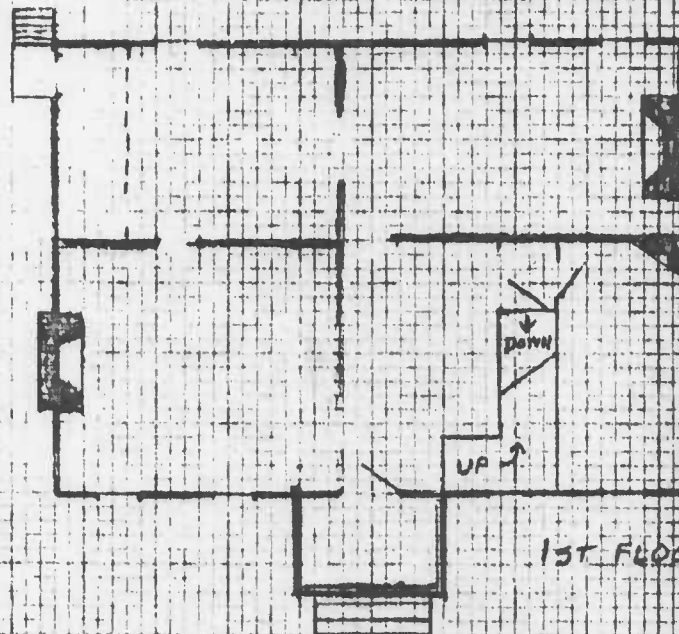
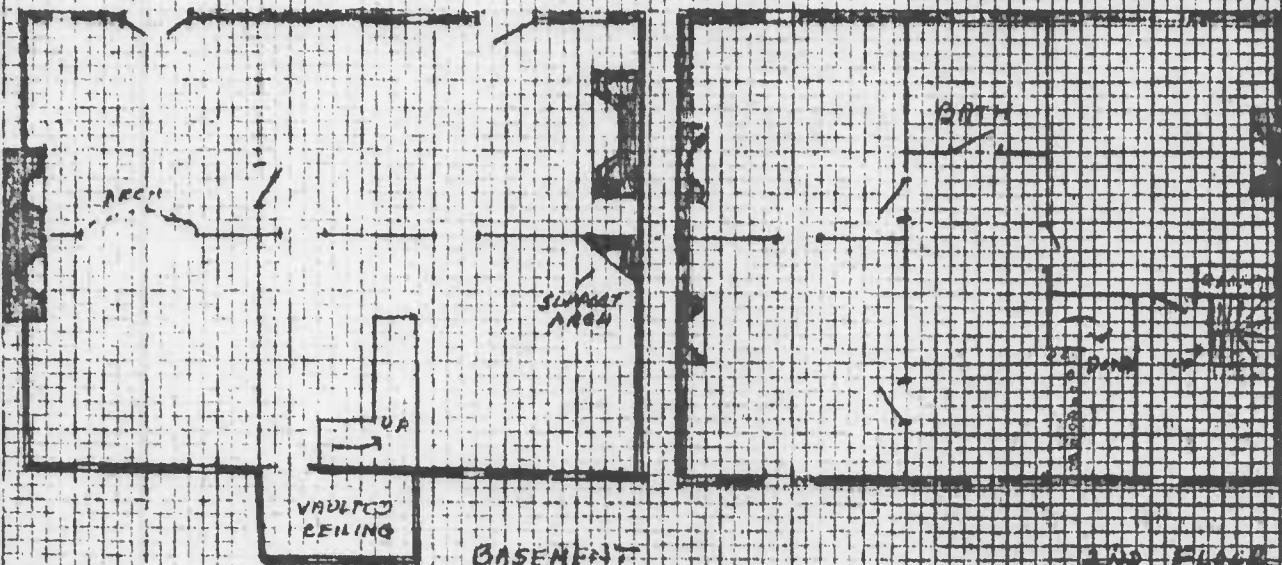
OLD STONE HOUSE  
GLADENSBURG  
MARYLAND

1ST FLOOR

BASEMENT

2ND FLOOR

SUPPORT  
ARCHES

SUPPORT  
ARCH

VAULTED  
CEILING

NOT DRAWN TO SCALE

The floor plan is similar on all three floors being that of a center hallway, with a room on either side of it at the front of the house. The hall terminates in the southwest room at the rear of the house on the first floor and in the cellar. The main entrance door (north facade) is panelled both inside and outside. It is extremely wide and has HL hinges. It is set in a conventional frame on the top and west side. The east side has no trim on the frame, being set flush with the east wall of the hallway. The door and window casings are about six inches wide. Only one

The cellar is divided into four rooms and has a concrete floor. All the walls and the ceiling are plastered over except in the area under the

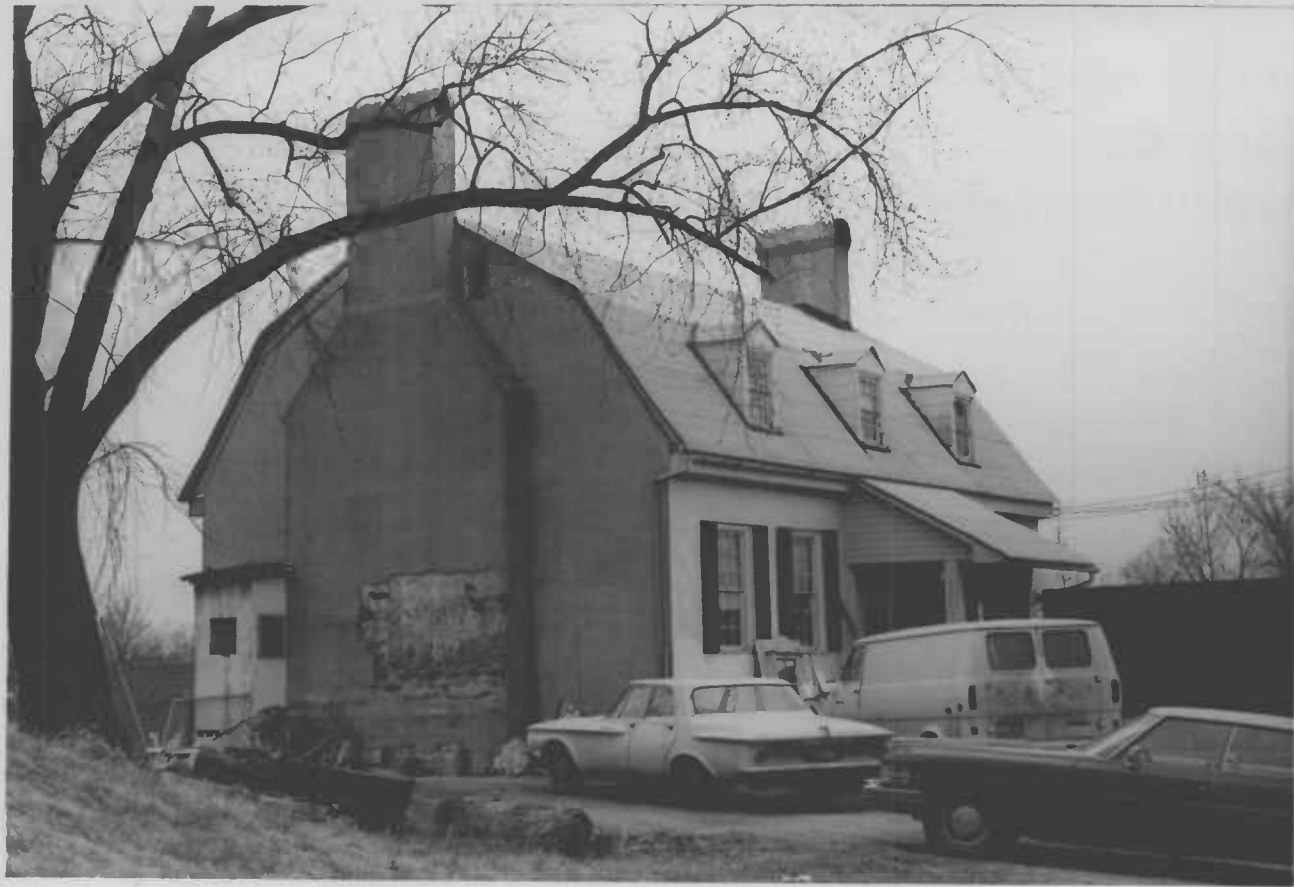
NAME MAGRUDER HOUSE

FACADE NE

PHOTO TAKEN 3/11/74 M DWYER

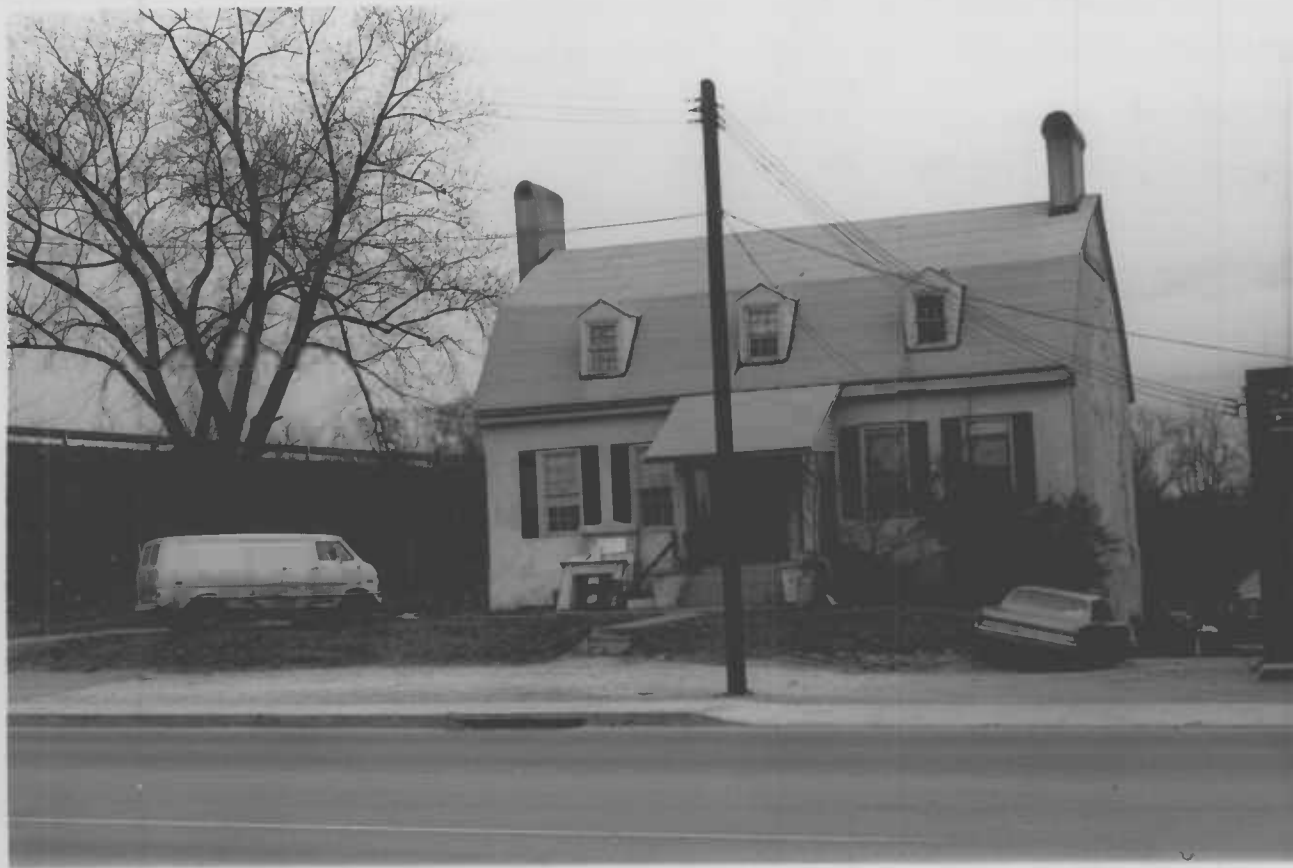
NAME MAGRUDER HOUSE (William Hilleary House PG: 69-7)

FACADE N

PHOTO TAKEN 3/11/74 M DWYER

The main entrance is centered on the five-bay north facade. On either side of it are two evenly spaced nine-over-nine-light sash windows. Four small basement windows are beneath these at ground level. The walls of the house, at the doorway, are curved inward, toward the doorway, decreasing their thickness. The wide door has six panels--two tall panels at the top and bottom and two square ones in the center. A modern doorway has been placed in the southeast corner of the house for outside access to the first floor kitchen. It has a small stoop and stairway leading to the rear ground level. The windows at the first floor level on the south side of the house are unevenly spaced as are the doors and windows on the ground level. All the openings at ground level have vaulted lintels of brick. Near the west end there is a door with a six-over-six window on each side of it. At the opposite end of the rear wall is a double-width door and one window of four lights.
